Carolina Quality Home Inspection
416 Lakeview Dr
Laurens, SC 29360

123 Any St
Simpsonville, SC 29681

SAMPLE REPORT

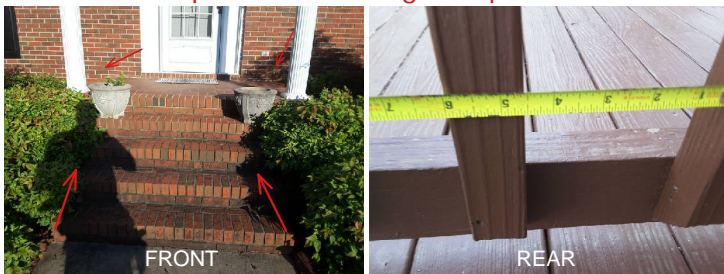
1. Railings: Wood=== Handrails missing (Safety), Spacing more than 4 inches apart could allow an adult, small child or pet to fall through, A qualified contractor is recommended to evaluate and estimate repairs

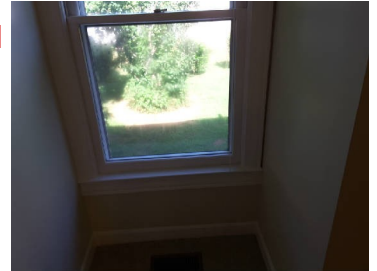
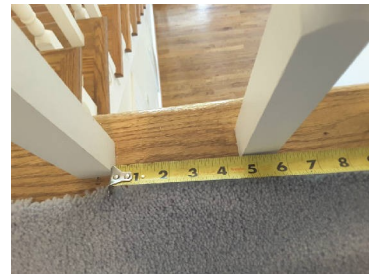
6. Windows: Double Pane Wood=== Some Windows are Stuck/Painted Shut will not open. A qualified contractor is recommended to evaluate and estimate repairs
7. Stairs (Interior): Wood stairs with wood handrails=== Spaced to far apart for safety. Spacing more than 4 inches apart could allow a small adult, child, or pet to fall through, A qualified contractor is recommend to evaluate and estimate repairs

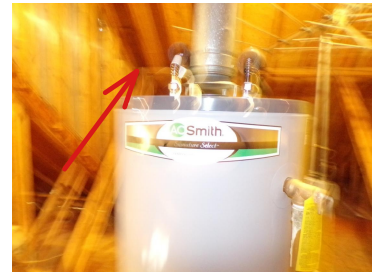
8. Attic Water Heater Water Heater Operation: Functional at time of inspection=== (Typical life span for gas water heater is 5 to 12 years), We do not give quotes or determine the life span for water heaters, Expansion tanks are recommended according to today's standards

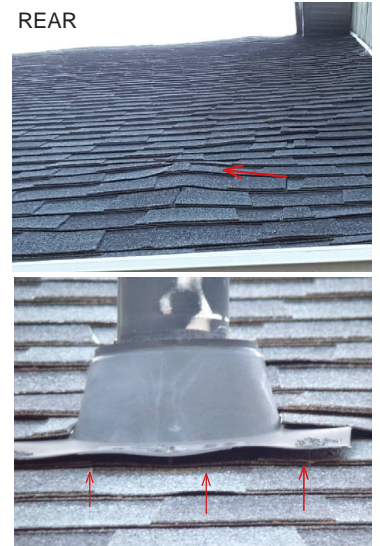
REAR

1. Material: Architectural Shingle=== Sheathing is damaged under shingles (SEE ATTIC), A qualified roofing contractor is recommended to evaluate and estimate repairs, We do not give quotes or determine the life span for roofing material
2. Plumbing Vents: PVC=== Loose/damaged boot, A licensed contractor is recommended to evaluate and estimate repairs

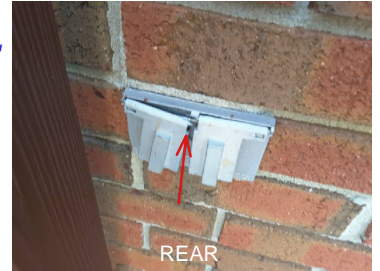
3. Exterior Electric Outlets: 110 VAC GFCI=== Loose/missing/damaged cover, A licensed electrician is recommended to evaluate and estimate repair, Functional at the time of the inspection
4. Hose Bibs: Functional at the time of the inspection, Water pressure is recommended to be at 40-80 psi=== Water pressure is 120 PSI, Excessive pressure noted, A licensed plumber is recommended to evaluate and estimate repairs

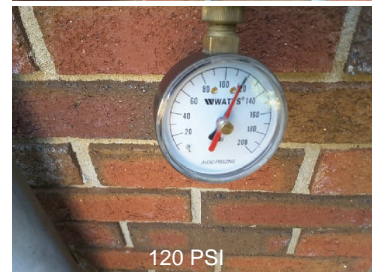
REAR

120 PSI

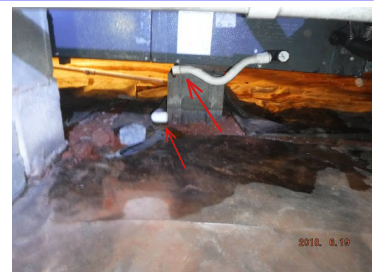
5. Condensate Removal: PVC=== Drain line is draining under the house, A qualified HVAC technician is recommended to evaluate and estimate repairs

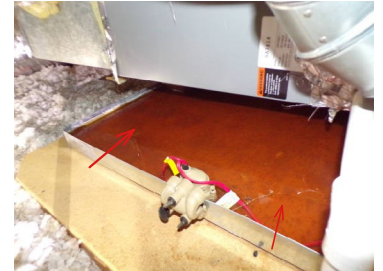
6. Condensate Removal: PVC=== Drain pain has rusted and full of water (SAFETY SWITCH IS NOT ALLOWING THE UNIT TO STAY ON), Drain line may be clogged, Insulation needed so condensation does not occur, A qualified HVAC technician is recommended to evaluate and estimate repairs

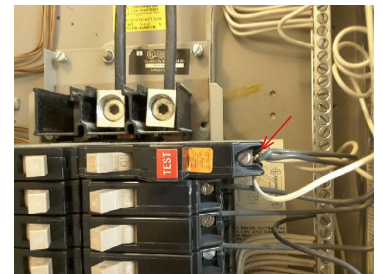
7. Outside, Laundry Room Electric Panel Manufacturer: Cutler-Hammer, Cutler-Hammer=== The doorbell transformer is not recommended in panel (RUBBING WIRE), A licensed electrician is recommended to evaluate and estimate repairs
8. Outside, Laundry Room Electric Panel Panel Type: Breakers=== Double taps are present at breakers. These circuits need to be moved to their own circuit breaker and cannot share a breaker. It is recommended that a qualified electrician inspect the new circuits and properly connect the new circuits to an individual breaker for each circuit

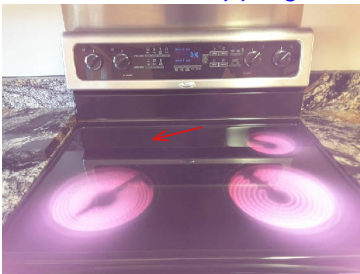
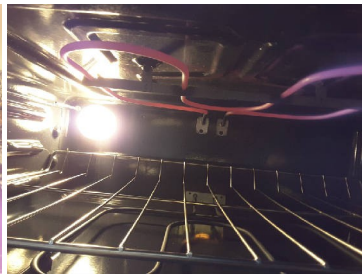
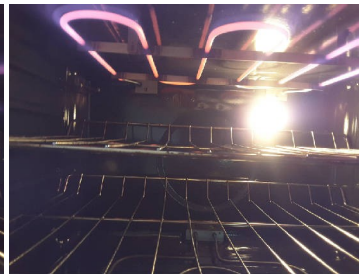
9. Cooking Appliances: Whirlpool=== Burner inoperative, A qualified contractor is recommended to evaluate and estimate repairs -- Note: Stove is missing Anti-tipping bracket - According to today's standards Anti-tipping bracket should be installed

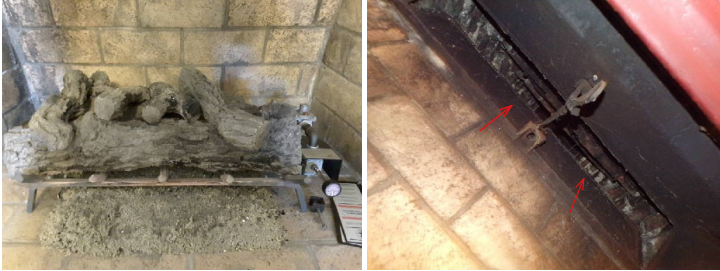
10. Living Room Fireplace Fireplace Construction: Brick=== Gas logs would not ignite at the time of inspection, A qualified contractor is recommended to evaluate and estimate repairs, Fireplace and components need cleaning and inspection prior to use

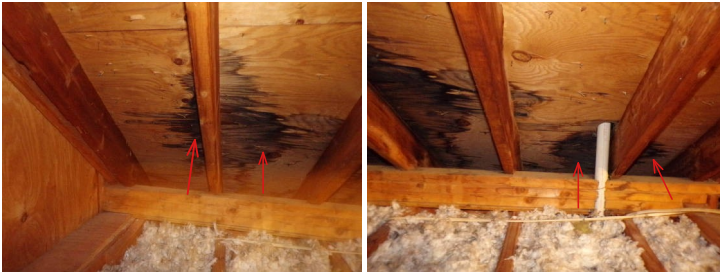
11. Sheathing: Plywood=== Water damage present, Was not wet at the time of inspection, A qualified roofing contractor is recommended to evaluate and estimate repairs

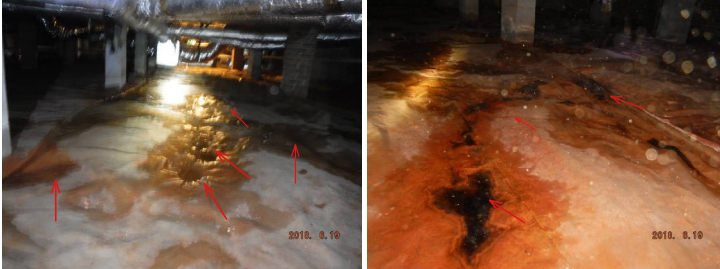
13. Moisture Penetration: Moisture Observed=== Wet/muddy in areas, Condensation drain line is leaking under the house, A qualified contractor is recommended to evaluate and estimate repairs

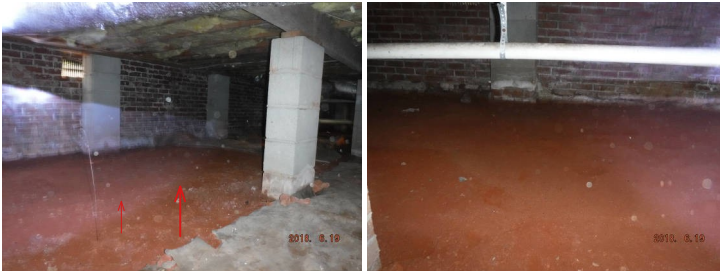
14. Vapor Barrier: Plastic=== Damaged/Torn Moisture/Vapor Barrier, Missing in areas, A qualified contractor is recommended to evaluate and estimate repairs

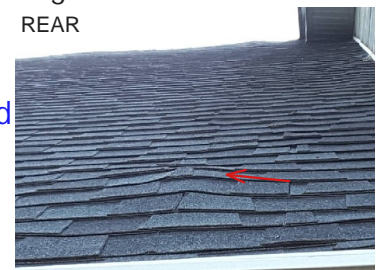
3. Inspected, Repair/Replace Material: Architectural Shingle=== Sheathing is damaged under shingles (SEE ATTIC), A qualified roofing contractor is recommended to evaluate and estimate repairs, We do not give quotes or determine the life span for roofing material

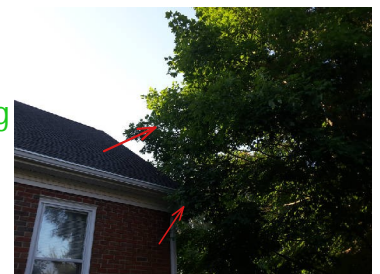
Trees/vegetation in contact with house should be removed, A Qualified landscaping specialist/tree company is recommended to evaluate and estimate repairs

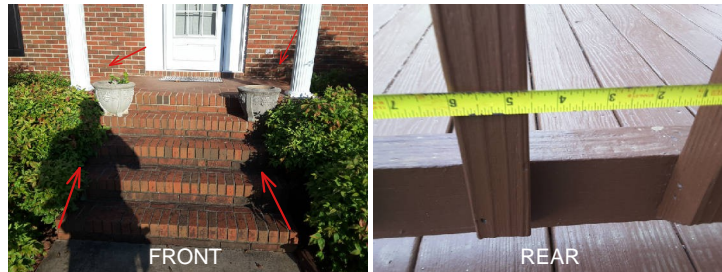
Railings: Wood=== Handrails missing (Safety), Spacing more than 4 inches apart could allow an adult, small child or pet to fall through, A qualified contractor is recommended to evaluate and estimate repairs

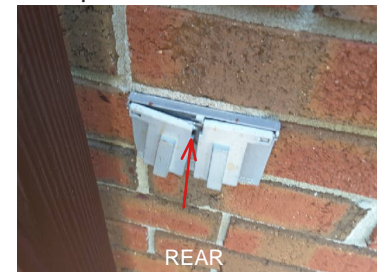
12. Inspected, Repair/Replace Exterior Electric Outlets: 110 VAC GFCI=== Loose/missing/damaged cover, A licensed electrician is recommended to evaluate and estimate repair, Functional at the time of the inspection

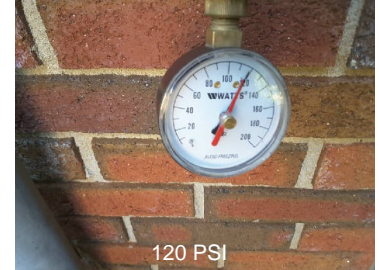
14. Inspected, Repair/Replace Hose Bibs: Functional at the time of the inspection, Water pressure is recommended to be at 40-80 psi=== Water pressure is 120 PSI, Excessive pressure noted, A licensed plumber is recommended to evaluate and estimate repairs

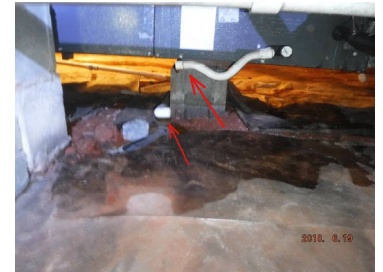
2. Inspected, Repair/Replace Condensate Removal: PVC=== Drain line is draining under the house, A qualified HVAC technician is recommended to evaluate and estimate repairs

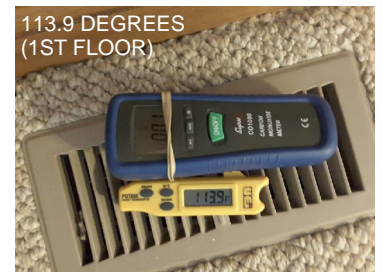
9. Inspected

Heating System Operation: Force Air Furnace, Appears functional at the time of inspection=== (Typical life span for force air furnace is 15 to 20 Years), We do not give quotes or determine the life span for HVAC equipment

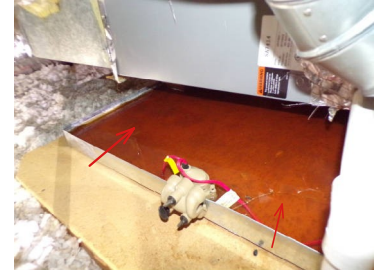
2. Inspected, Repair/Replace Condensate Removal: PVC=== Drain pain has rusted and full of water (SAFETY SWITCH IS NOT ALLOWING THE UNIT TO STAY ON), Drain line may be clogged, Insulation needed so condensation does not occur, A qualified HVAC technician is recommended to evaluate and estimate repairs

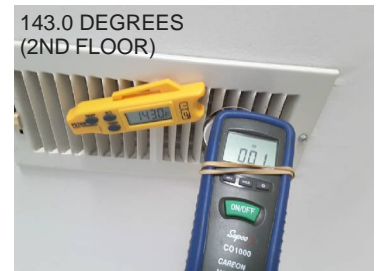
9. Inspected Heating System Operation: Force Air Furnace, Appears functional at the time of inspection=== (Typical life span for force air furnace is 15 to 20 Years), We do not give quotes or determine the life span for HVAC equipment

10. Manufacturer: Armstrong
11. Area Served: 2nd floor Approximate Age: 2017
12. Fuel Type: Natural gas
13. Inspected Flue Pipe: Double wall
14. Inspected Thermostats: Digital

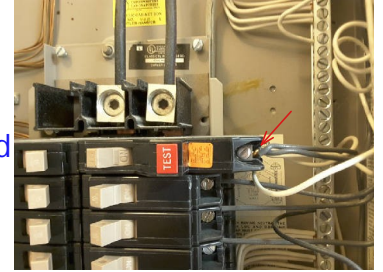
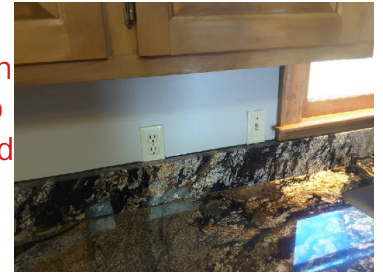
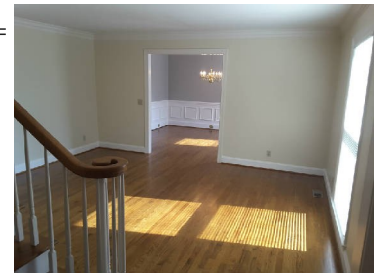
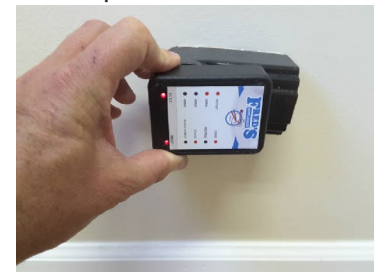
7. Inspected, Repair/Replace Panel Type: Breakers=== Double taps are present at breakers. These circuits need to be moved to their own circuit breaker and cannot share a breaker. It is recommended that a qualified electrician inspect the new circuits and properly connect the new circuits to an individual breaker for each circuit

11. Inspected, Safety GFCI: GFCI reset in breaker box, None present=== GFCI not present Kitchen, Recommended GFCI's within 6 feet of water, GFCI's are recommended according to today's standards, A licensed electrician is recommended to evaluate and estimate repairs, Bathroom GFCI are Functional at the time of inspection

16. Inspected, Safety Carbon Monoxide Detectors: None present=== There is no carbon monoxide detector found in home. It is recommended that one be installed according to the manufacturer's instructions.

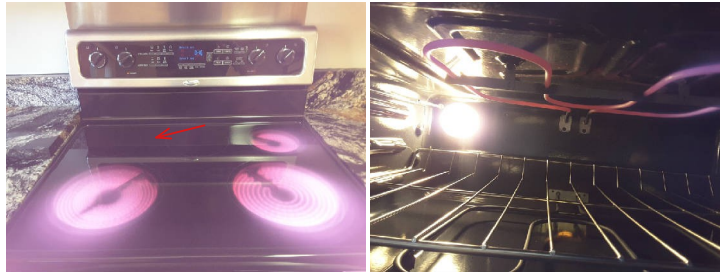
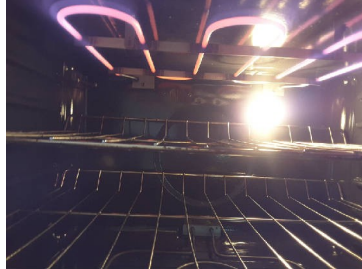
- Inspected, Repair/Replace **Cooking Appliances:** Whirlpool=== **Burner inoperative, A qualified contractor is recommended to evaluate and estimate repairs -- Note: Stove is missing Anti-tipping bracket - According to today's standards Anti-tipping bracket should be installed**

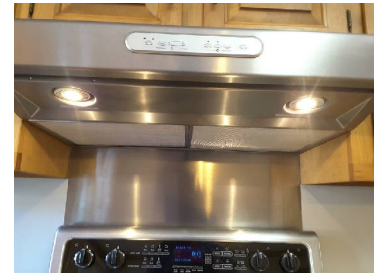
2. Inspected

Exhaust/Range Hood: Re-circulating===
Functional at the time of inspection

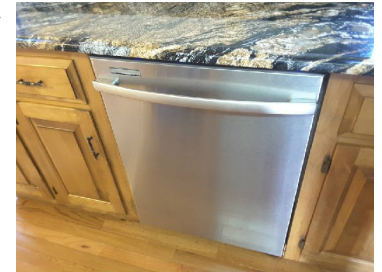
4. Inspected

Dishwasher: Whirlpool=== Functional at the time of
inspection

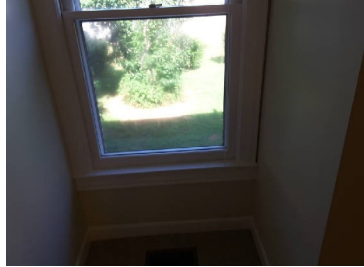
| 8. Inspected, Safety | Windows: Double Pane Wood=== Some Windows are Stuck/Painted Shut will not open. A qualified contractor is recommended to evaluate and estimate repairs | |

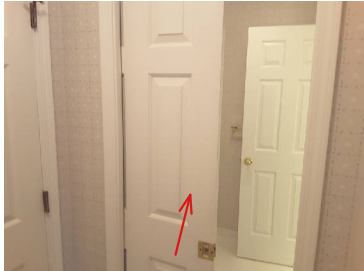
| 10. Inspected, Maintenance/Cosmetic | DOORS: Hollow wood=== Align/adjust doors to close properly | |

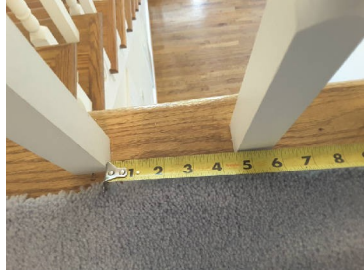
| 11. Inspected, Safety | Stairs (Interior): Wood stairs with wood handrails=== Spaced to far apart for safety. Spacing more than 4 inches apart could allow a small adult, child, or pet to fall through, A qualified contractor is recommend to evaluate and estimate repairs | |

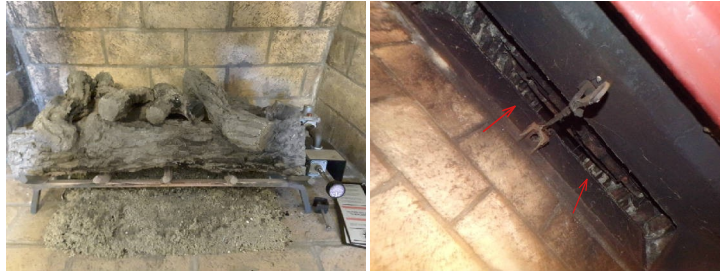
1. Inspected, Repair/Replace Fireplace Construction: Brick=== Gas logs would not ignite at the time of inspection, A qualified contractor is recommended to evaluate and estimate repairs, Fireplace and components need cleaning and inspection prior to use

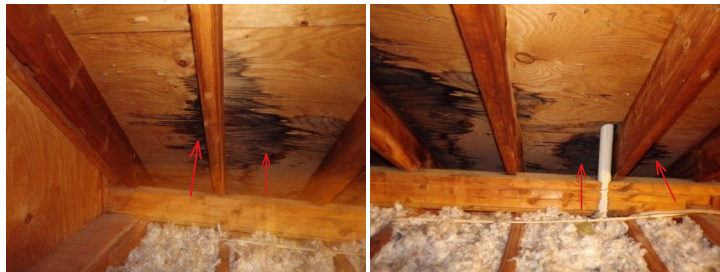
5. Inspected, Repair/Replace Sheathing: Plywood=== Water damage present, Was not wet at the time of inspection, A qualified roofing contractor is recommended to evaluate and estimate repairs

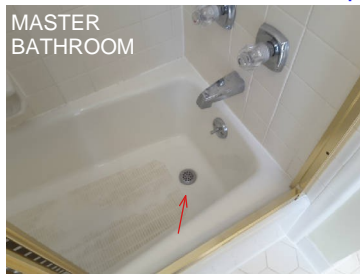
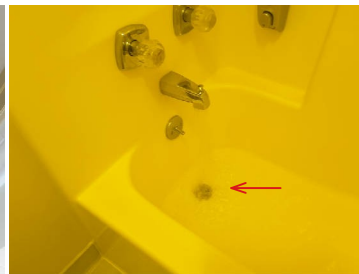
5. Inspected, Repair/Replace Water Supply/Distribution/Fixtures: Copper=== Missing or faulty drain stopper (CHECK ALL BATHROOMS), A licensed plumber is recommended to evaluate and estimate repairs

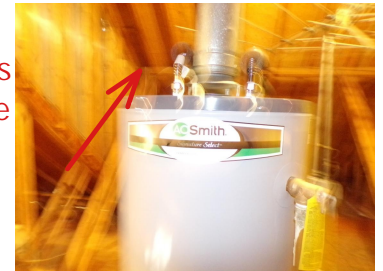
11. Inspected, Safety Water Heater Operation: Functional at time of inspection=== (Typical life span for gas water heater is 5 to 12 years), We do not give quotes or determine the life span for water heaters, Expansion tanks are recommended according to today's standards

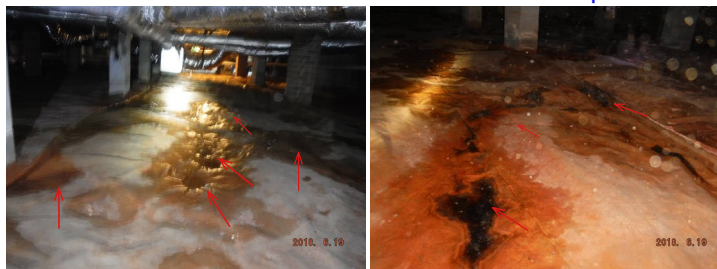
1. Method of Inspection: In the crawl space
2. Inspected Unable to Inspect: 30%=== Limited Access due to: Blocked by duct work, Insulation, Plumbing
3. Inspected Access: Wood door
4. Inspected, Repair/Replace Moisture Penetration: Moisture Observed=== **Wet/muddy in areas, Condensation drain line is leaking under the house, A qualified contractor is recommended to evaluate and estimate repairs**

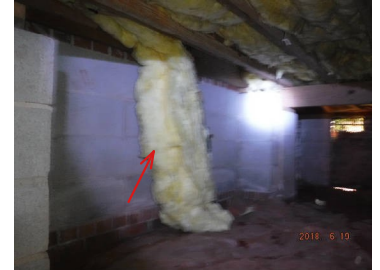
5. Inspected, Maintenance/Cosmetic **Insulation: Fiberglass=== Insulation that has fallen to the ground or has become damp from the ground or from condensation usually needs to be replaced with new insulation, A qualified contractor is recommended to evaluate and estimate repairs**

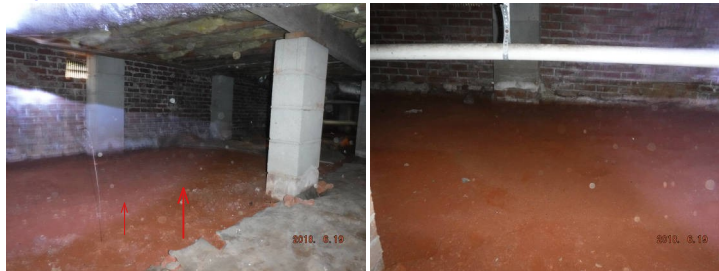
6. Inspected, Repair/Replace **Vapor Barrier: Plastic=== Damaged/Torn Moisture/Vapor Barrier, Missing in areas, A qualified contractor is recommended to evaluate and estimate repairs**
